## A 50% MTBF increase whilst sealing a corrosive lime slurry

## “Increasing MTBF and reducing costs”

| Reference N.O: | CH00763 |

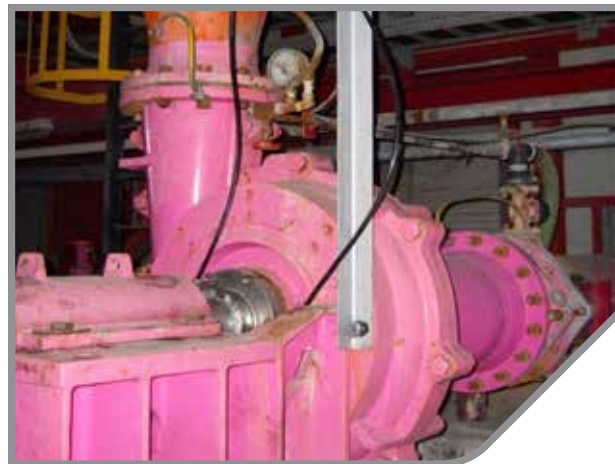
The pumps were failing every 12 months and because they pump corrosive lime slurry, the leakage was damaging the pump body and base increasing the repair bill. AESSEAL® installed a cartridge mounted double seal (CDSA) along with a SP seal support system in November 2009.

The new solution has increased the mean time between failures by over 50% and helped reduce the annual maintenance bill by over €3,000. The new seal and seal support system is configured to ensure that there is no leakage of the corrosive lime slurry in the event of seal failure, increasing plant safety and helping to reduce maintenance costs.
